The Soils of Archeological Sites in Middle Egypt: Risk assessment

ABSTRACT

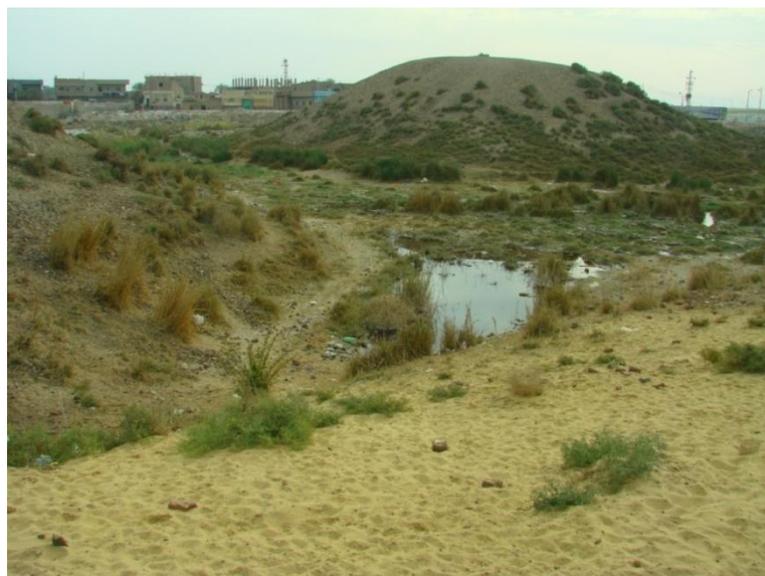
Fig. 2: Eroded surface filled with water in El-Bahnasa area; note that the evidence of native vegetation reduced the surface erosion

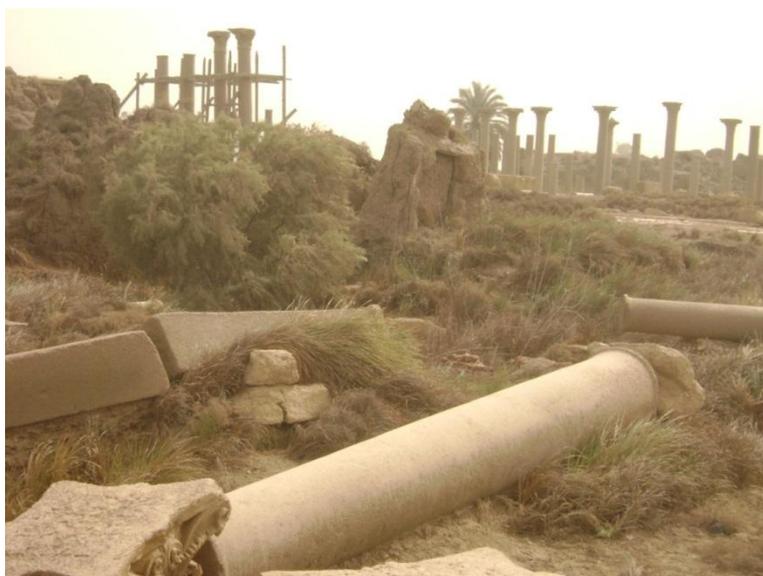
Fig. 3: Eroded surfaces; note that the evidence of native vegetation indicates the shallow water table
